**MONITORING AND ANALYSES OF THE 2013–2014  
SAGAPONACK & BRIDGEHAMPTON–WATER MILL  
BEACH EROSION CONTROL DISTRICTS  
NOURISHMENT PROJECT**

**2017 BEACH MONITORING**

**2017  
BEACH MONITORING REPORT**

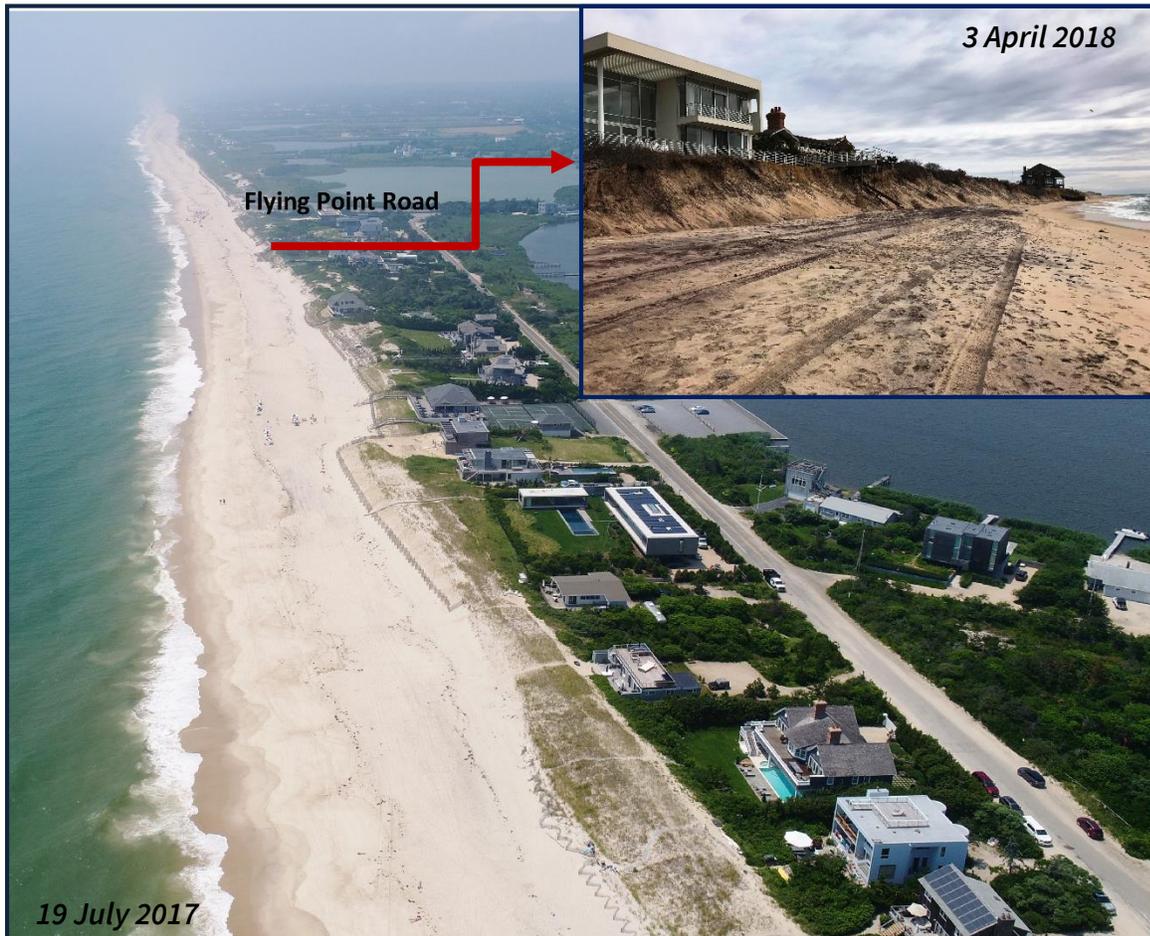
**COVER PHOTO:** Aerial photo taken on 19 July 2017 from west of Mecox Bay looking southwest to the project limit at Water Mill. Ground photo taken at high tide on 3 April 2018 after the series of nor'easters in March. Escarpments were observed, and a section of bulkhead was re-exposed.

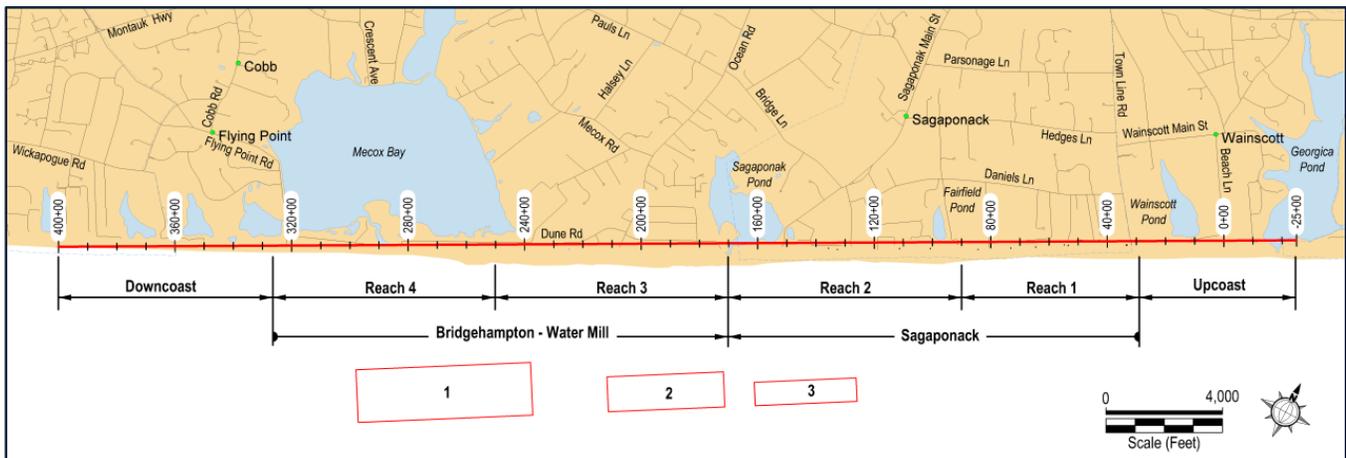
**FIGURE 1.2.** Project limits and monitoring ranges of the 1-mile upcoast (between stations -25+00 and 25+00) and 1.5-mile downcoast (between stations 330+00 and 400+00) along with offshore borrow areas.

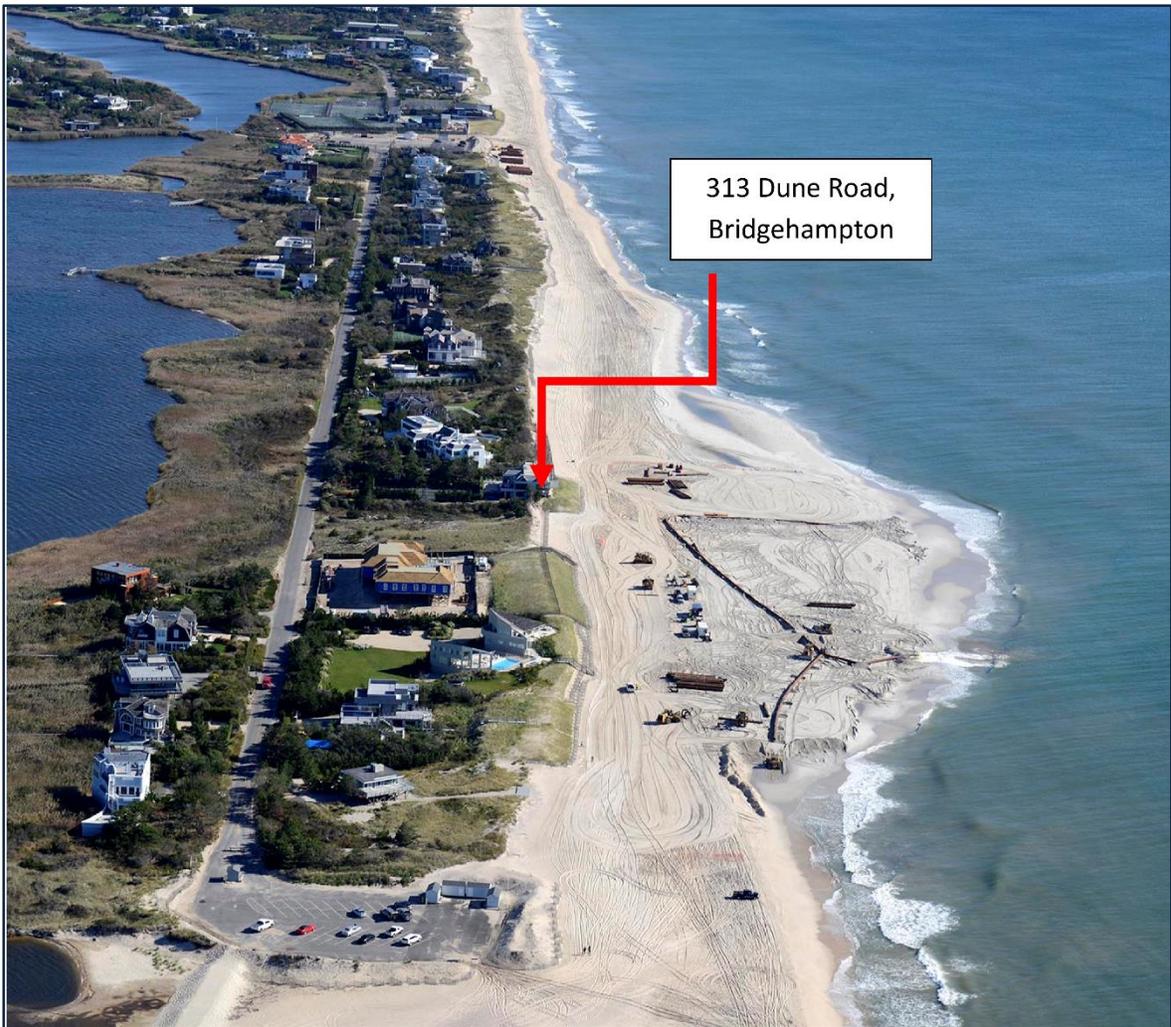
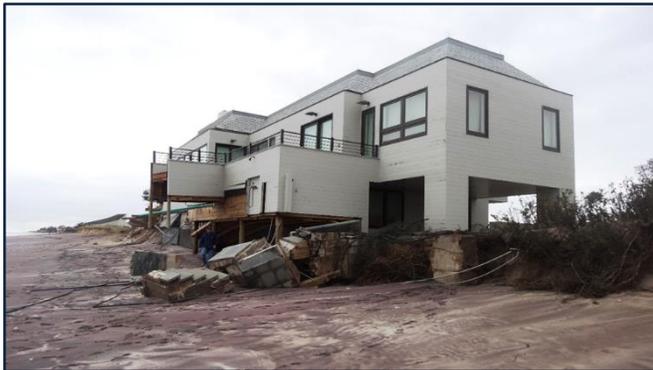
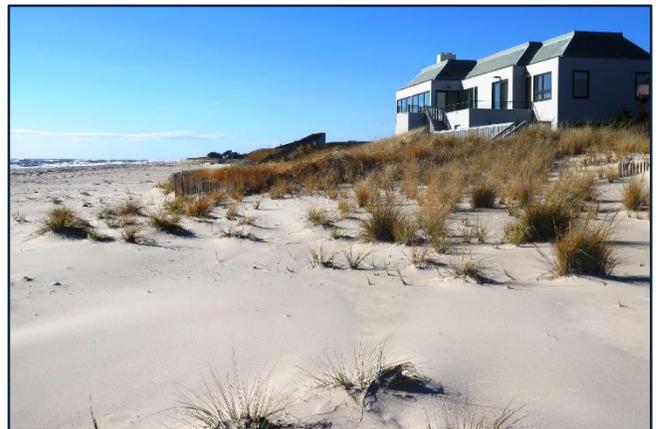
**FIGURE 1.3.** Photos taken in the vicinity of 313 Dune Road, Bridgehampton (NY). Aerial image (upper) taken during nourishment construction showing the location of the property in the lower photos: After Superstorm *Sandy* in 2012 (lower left) and 3.5 years after nourishment in 2017 (lower right). [Photos by First Coastal Corporation, Westhampton (NY)]

CSE’s survey in April 2013 confirmed there was a net loss of sand due to Hurricane *Sandy* (29 October 2012) and the 2013 winter storms in the probable range of 500,000–750,000 cy for the Sagaponack–Bridgehampton project area. Hurricane *Sandy* caused some of the worst dune recession in the past century along the south shore of Long Island, ranking with the Great Hurricane of 1938, the “Ash Wednesday” storm of March 1962, and the great nor’easters of 1991–1992. Figure 1.3 shows some post-storm escarpments and undermined foundations in the project area.

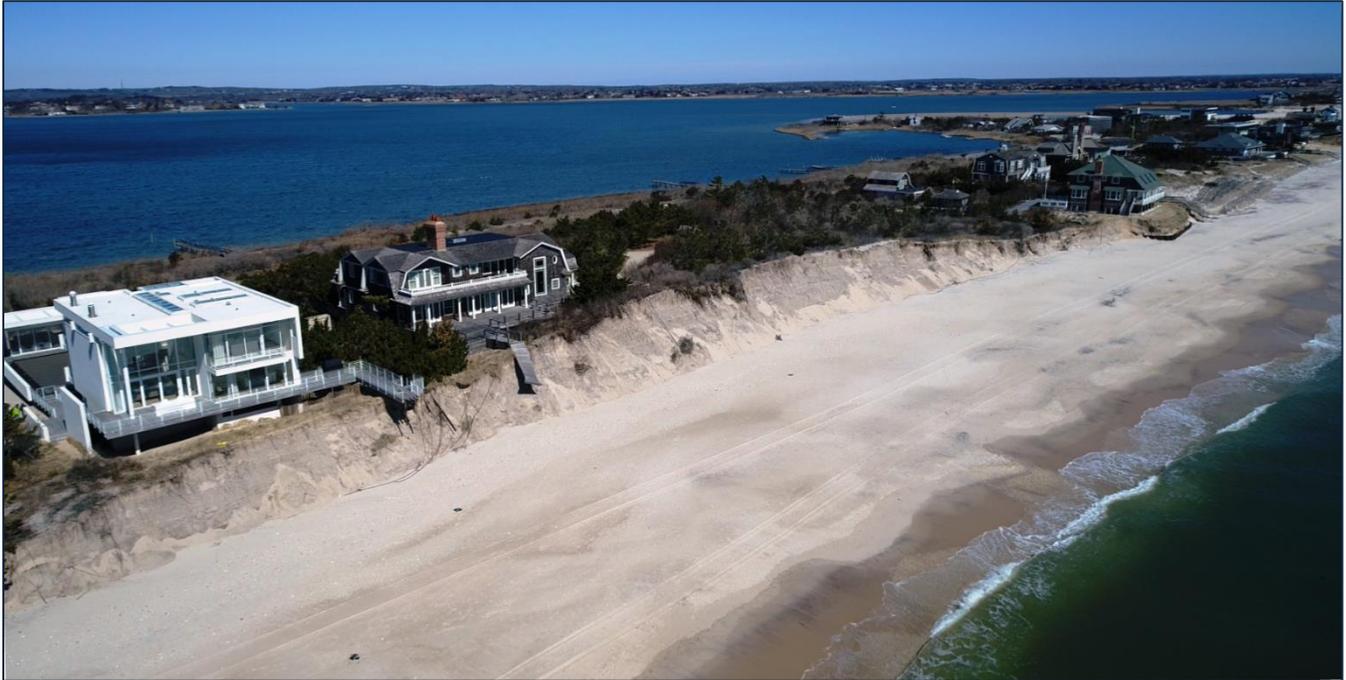
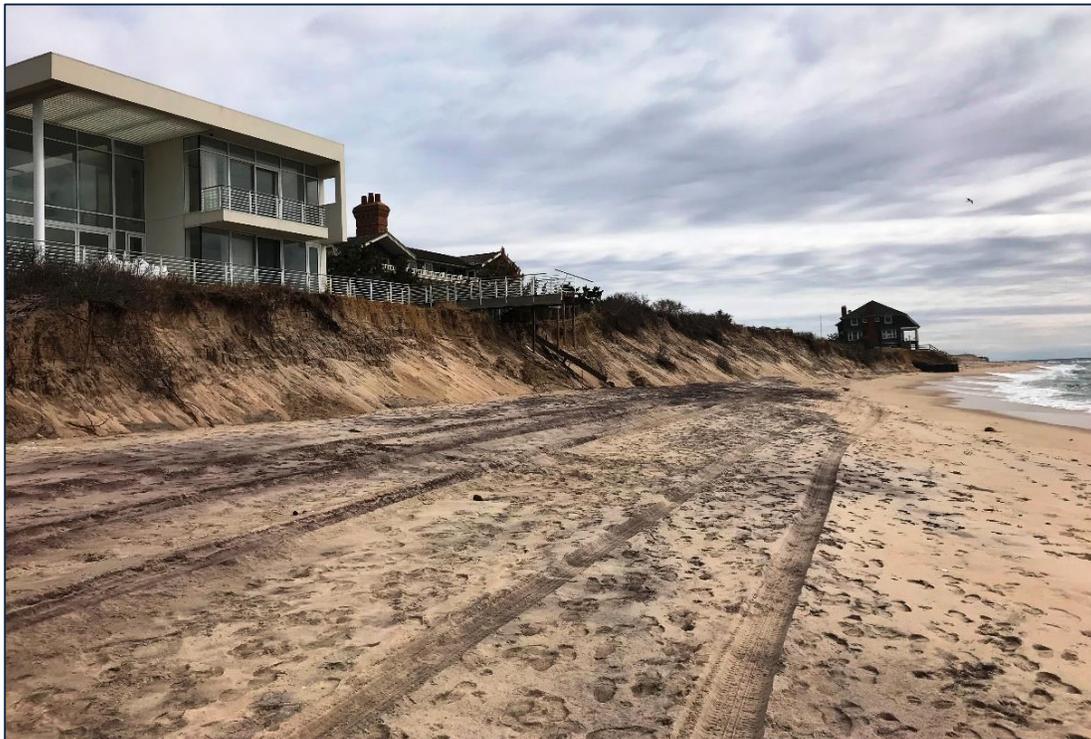
Escarpsments were observed in a number of localities, particularly alongshore west of Mecox Bay where the beach was narrower (Fig 4.5, upper). Associated with the escarpments, a portion of the bulkhead that was buried naturally after the 2013–2014 nourishment project became re-exposed after the storms (Fig 4.5, lower). The beach in front of these areas was barely passable during high tides.

**FIGURE 4.5.** [UPPER] Aerial photo taken by First Coastal on 11 March 2018 after a nor'easter. Escarpments were observed alongshore west of Mecox Bay. [LOWER] Ground photo taken west of Mecox Bay by CSE on 3 April 2018 at high tide during the beach inspection. A section of bulkhead was re-exposed after the March nor'easters.

If constructed properly, a nourished beach will respond to changing water levels and waves just like the natural beach did before the project. But a principal goal of nourishment is to produce a wider beach so that the seasonal changes in beach width do not encroach on the foredune. A good indicator of success is whether all areas of the project make it through storm and seasonal changes in the beach without adverse impact to the foredune. So far, the project is performing well by that measure. It is expected that the beach will naturally recover during the summer season, and the exposed bulkhead will be re-buried by wind-generated sand.

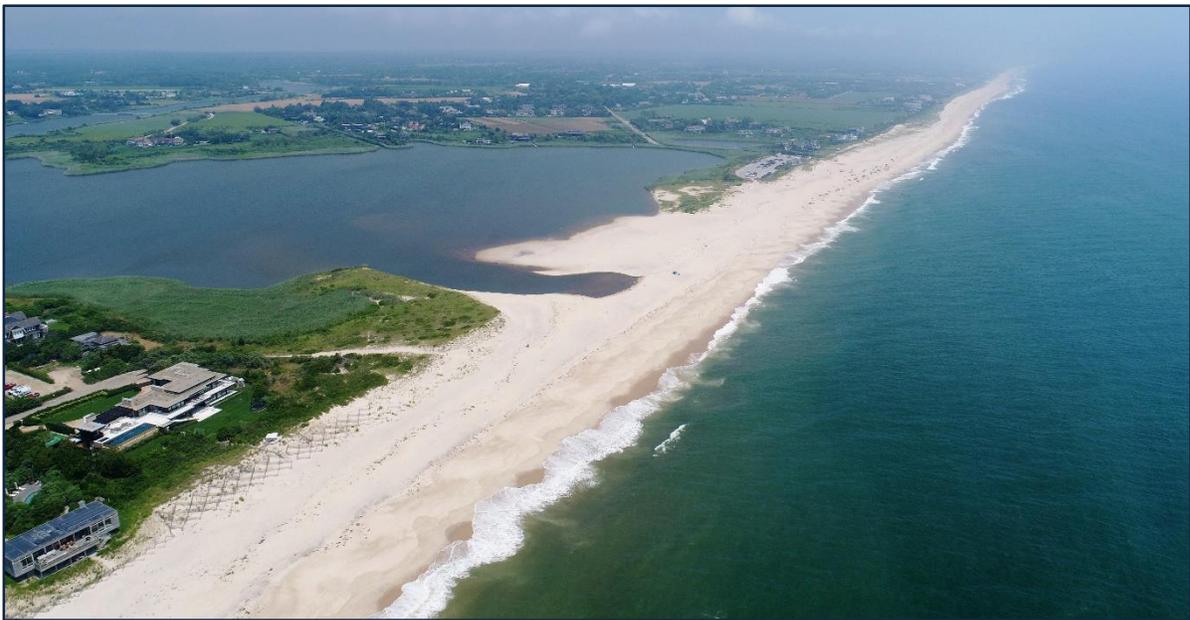
**Photo 3.** Sagaponack Pond is located in the middle of the photo. The pond was closed at the time of the photo.
